# Hydraulic analysis of river training cross-vanes as part of post-restoration monitoring

T. A. Endreny<sup>1</sup> and M. M. Soulman<sup>2</sup>

**Abstract.** River restoration design methods are incrementally improved by studying and learning from monitoring data in previous projects. In this paper we report post-restoration monitoring data and simulation analysis for a Natural Channel Design (NCD) restoration project along 1600 m of the Batavia Kill (14 km<sup>2</sup> watershed) in the Catskill Mountains, NY. The restoration project was completed in 2002 with goals to reduce bank erosion and determine the efficacy of NCD approaches for restoring headwater streams in the Catskill Mountains, NY. The NCD approach used a reference-reach to determine channel form, empirical relations between the project site and reference site bankfull dimensions to size channel geometry, and hydraulic and sediment computations based on a bankfull (1.3 yr return interval) discharge to test channel capacity and sediment stability. The NCD project included 12 cross-vanes and 48 j-hook vanes as river training structures along 19 meander bends to protect against bank erosion and maintain scour pools fo

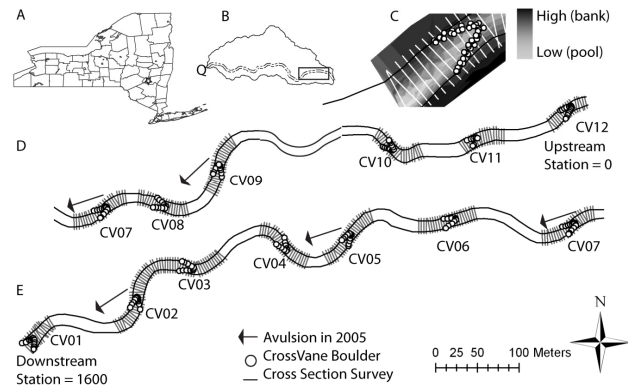
**Fig. 1.** (A) Location in New York of (B) Batavia Kill watershed. (C) Diagram of a cross-vane and its scour pool. (D) Upstream reach of restoration project with 6 cross-vanes and (E) downstream reach of project, where arrows show the avulsion sites.

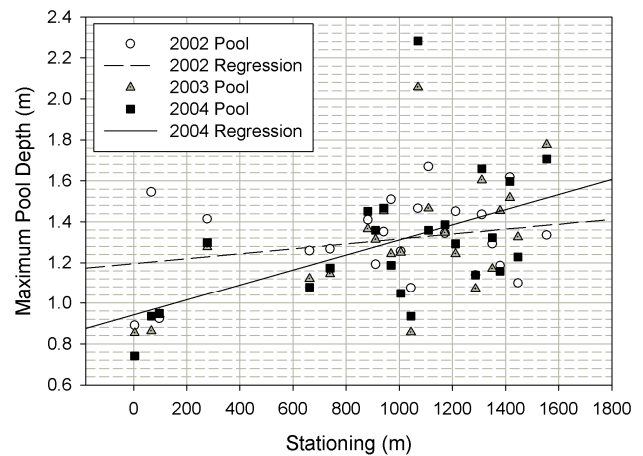
**Fig. 2.** Maximum pool depth for 24 monitored pool cross-sections for 2002, 2003, and 2004 with trend lines for 2002 and 2004 (upstream stationing is 0 m).

Between 2002 and 2004, pool depth generally increased in the downstream direction in the Big Hollow restoration project (Fig. 2). In 2002 the upstream 800 m of the project had average pool depths of 1.2 m, only 0.1 m shallower than

the downstream 800 m of project average pool depths. In 2002 the upstream section had the only 3 pools shallower than 1 m. In 2004 the upstream pools had aggraded to an average depth of 1 m, while the downstream pools had increased to an average depth of 1.4 m, with one pool scouring from 1.5 to 2.3 m. By 2004 6 of the 7 upstream pools had partially aggraded. In the downstream section, the trend for pools was mixed, with 9 of 17 pools aggrading, including those downstream of the later avulsions. A survey of the cross-sections after the 2005 flood documented aggradation in the pools downstream of the avulsions (Buck-Engineering PC, 2006).

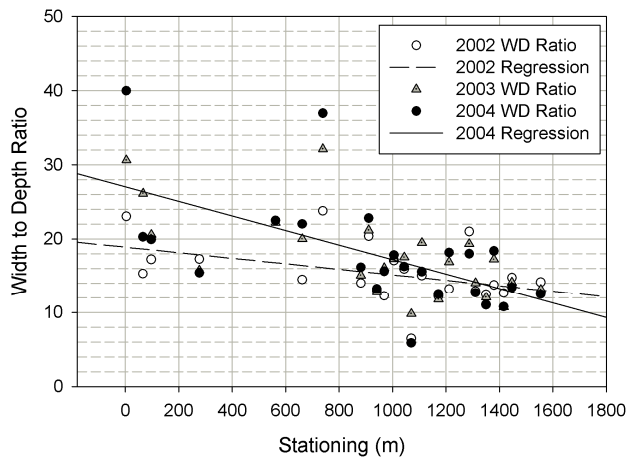
**Fig. 3.** Width-to-depth ratios for 24 monitored pool cross-sections for 2002, 2003, and 2004 with trend lines for 2002 and 2004 (upstream stationing is 0 m).

Width-to-depth ratio decreased in the downstream direction (Fig. 3), with several monitored banks eroding between 1 and 9 m and aggradation on the opposite bank not completing the lateral migration (Buck-Engineering PC, 2006). Reach average width-to-depth ratios were 15 in 2002 and 18 in 2004. In the 800 m upstream section, the average ratio increased from 18 in 2002 to 24 in 2004, while the 800 m downstream section had an average ratio of 14 across the 3 yr. The upstream to downstream trend in decreasing ratios steepened between 2002 and 2004. Despite variation in width-to-depth ratios, all of the measured values were within the normal range reported for stable cross-vane restored rivers (Radspinner et al., 2010). Detailed analysis of cross-section morphology from 2002 to 2004 revealed the upstream pools within meander bends were eroding at one bank and filling with sediment elsewhere and became morphologically similar to plane bed or riffle sections (Buck-Engineering PC, 2006). HEC-RAS simulation of bankfull discharge for the 2004 morphology was used to examine how aggradation impacted cross-sectional area. Analysis of model output included 267 cross-sections, with 100 pool cross-sections. The analysis showed the 25th quartile pool cross-sectional area

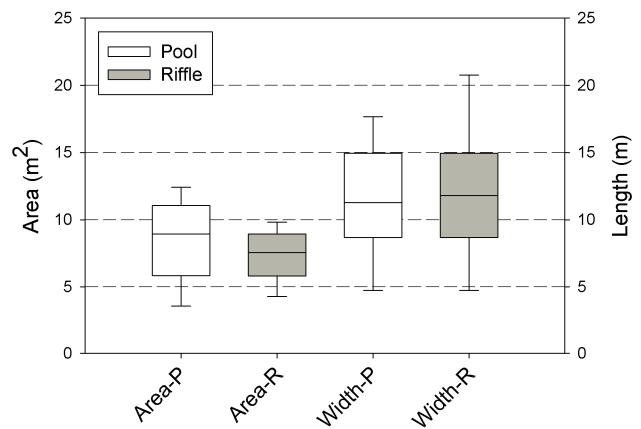
**Fig. 4.** Box and whiskers plot of bankfull flow cross-sectional area and width for pools and riffles based on HEC-RAS simulation with 2004 survey data.

was smaller than the 25th quartile riffle area, and the pool and riffle widths were nearly equal (Fig. 4).

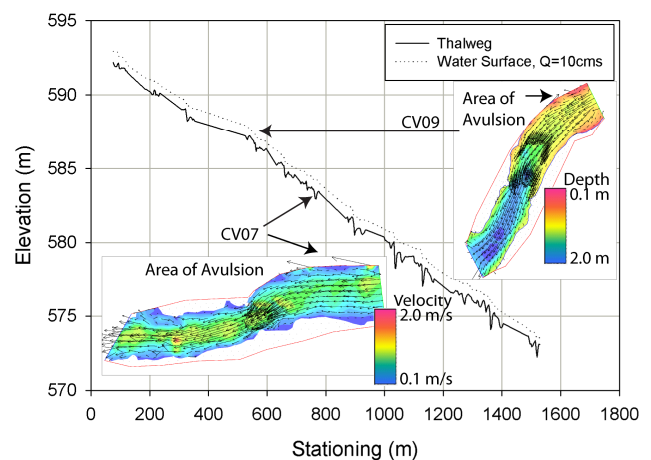
An analysis of river hydraulic slopes passing over vanes and shear forces along the bed was conducted using HEC-RAS simulations with the 2004 bed geometry and bankfull discharge. The simulated water surface profile had rapidly varied flow at all cross-vanes, with hydraulic jumps predicted in many of the pools (Fig. 5). The hydraulic jumps below vanes are associated with deeper pools and this situation contrasts with the absence of hydraulic jumps in the meander bends where there was notable aggradation of the pools. Pools below vanes varied in depth, and the deeper pools had steep water surface and energy grade line slopes ranging between 10–20 %. A cross-section shear force of  $60 \text{ Nm}^{-2}$  was the median model value predicted by HEC-RAS for bankfull discharge, but in the deeper pools the shear was above  $140 \text{ Nm}^{-2}$ . Based on Shields critical shear stress analysis

the median shear force can move the Big Hollow 50 % diameter (D50) particle of 63 mm and the deeper pool shear force can move the D84 particle of 200 mm. The flatter and shallower pool and riffle sections would not have the competence to move these D84 particles. River velocity vectors were analyzed with the River2D simulations to examine whether the river training structures were steering velocity off the scour banks. River2D simulations of the 2004 bed form near cross-vanes 7 and 9 identified velocity vectors striking against the banks where the avulsions occurred (see Fig. 5, inset). The absence of river training devices allowed high velocity vectors to access the bank and initiate the avulsions.

**Fig. 5.** HEC-RAS predicted water surface slopes along the project reach with inset of River2D predicted flow velocity and depth with velocity vectors at cross-vane 7 and 9.
