Use of the 3-D scanner in mapping and monitoring the dynamic degradation of soils: case study of the Cucuteni-Baiceni Gully on the Moldavian Plateau (Romania)

G. Romanescu¹, V. Cotiuga², A. Asandulesei², and C. Stoleriu¹

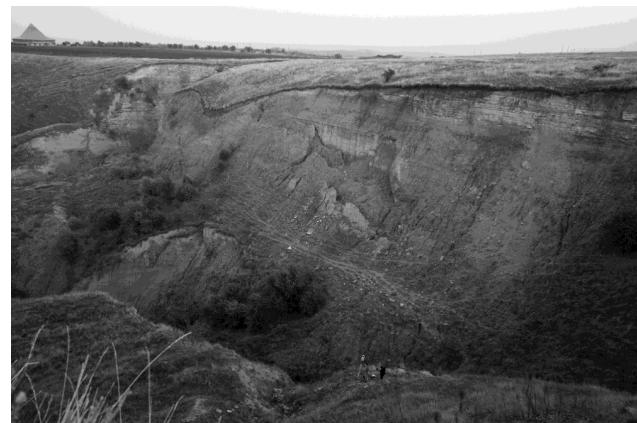
Fig. 19. The Cucuteni-Baiceni Gully.

This material contributed to the local aggradation of the gully (Fig. 19).

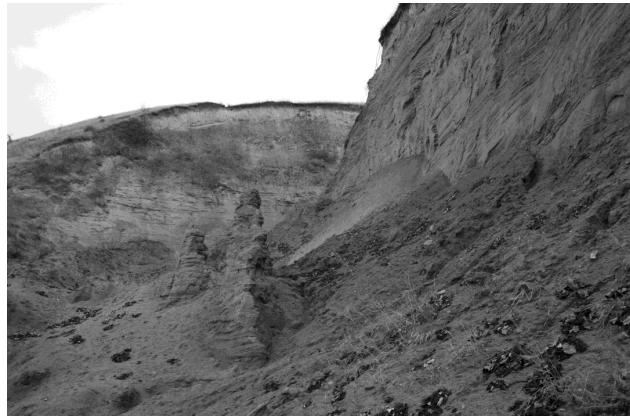
Fig. 21. Massive landfall and development of a ruiniform landscape at the base of the versants.

The fastest slope recession occurs following landslides and collapses (Fig. 21). The rotational displacement of the materials leads to the development of aeolianly-modelled outliers at the basis of the steep versants.

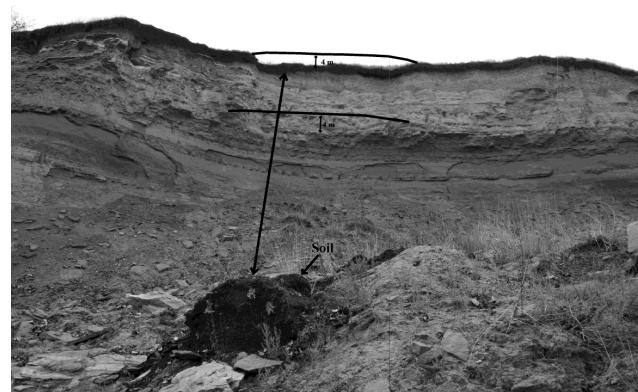
Fig. 22. The fall of the overhanging versant.

The most spectacular landfall from between 2008 and 2010 occurred in the spring of the latter year. The collapse of a 4-m-thick cornice overhanging a versant was favoured by the rich precipitations, which strongly dampened a sandy-clayish layer that was extremely friable (Fig. 22). One year after the episode, the material present at the base of the

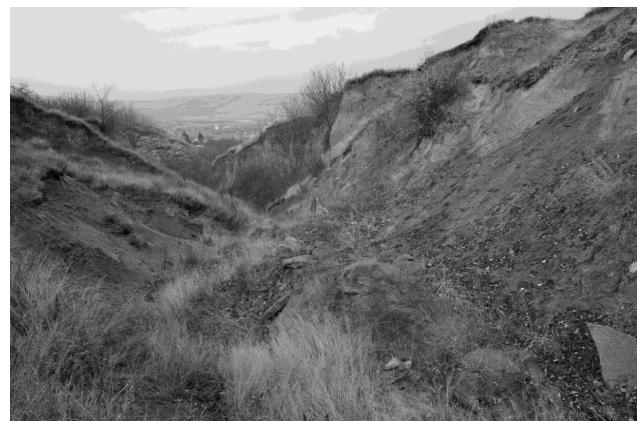
Fig. 23. The depositing of the fallen material in the secondary thalweg.

The entire versant now left hanging can collapse at the first strong rain, and the gully's quick rate of advancement could thus increase further more during the period to come. The drought from 2011, the strongest ever recorded in Romania during the recent period, led to a slow-down of the water erosion process. It is for this reason that the material accumulated in the gully, on the slopes or along the thalweg has not been eliminated (Figs. 23 and 24).
